## LEAK DETECTION REPORT

<b>Property Address</b>	[REDACTED]
<b>Customer Name</b>	[REDACTED]
<b>Job Contact</b>	
<b>Customer Order No</b>	71967
<b>Job Status</b>	Leak detected - Further work required

Domestic double storey town house.

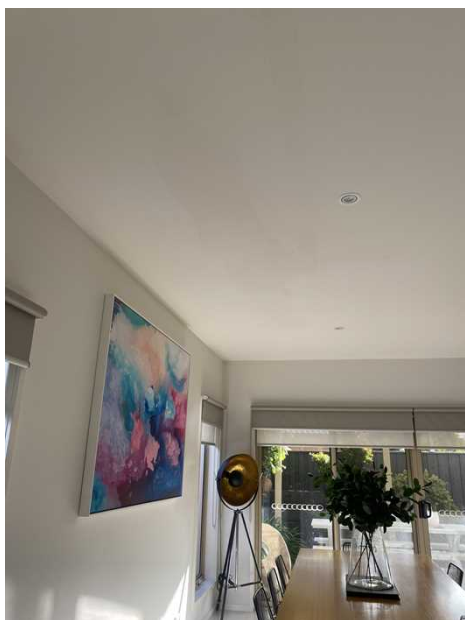
Moisture detected on plaster ceiling in the dining room below north & east side lower roofs/box gutters. Suspected overflow from non compliant box gutters & roofing.

Water stained ceiling in dining room.

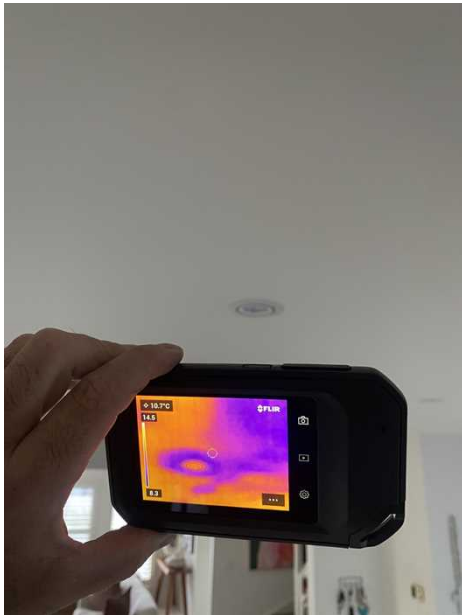
Thermal imaging moisture detected.

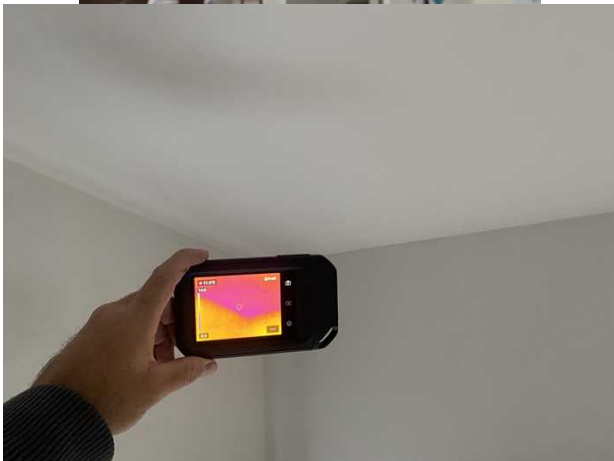
Thermal imaging moisture detected below box gutters.

Leak detected from north east lower roofs & box gutters.

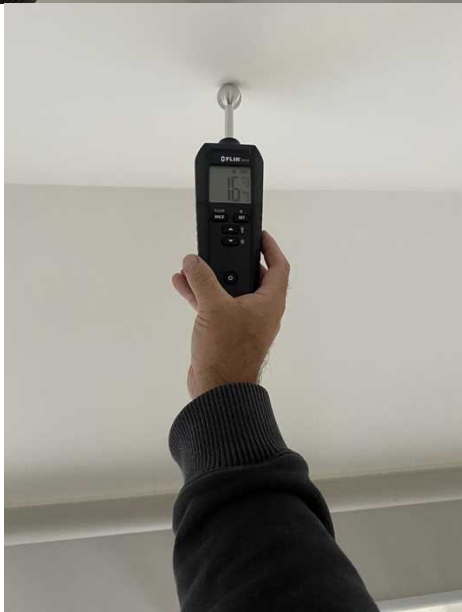
Moisture meter.

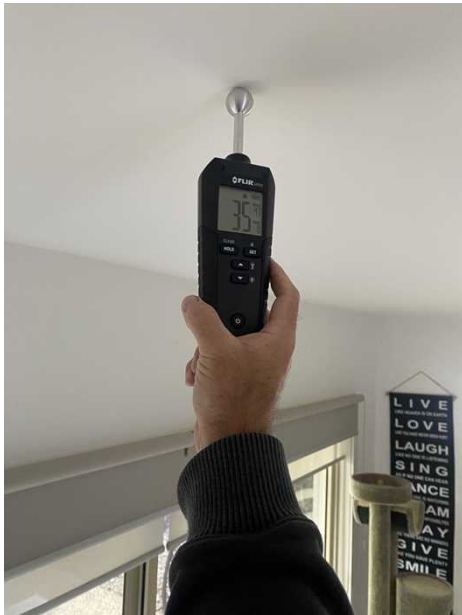
Moisture meter high reading below box gutters.

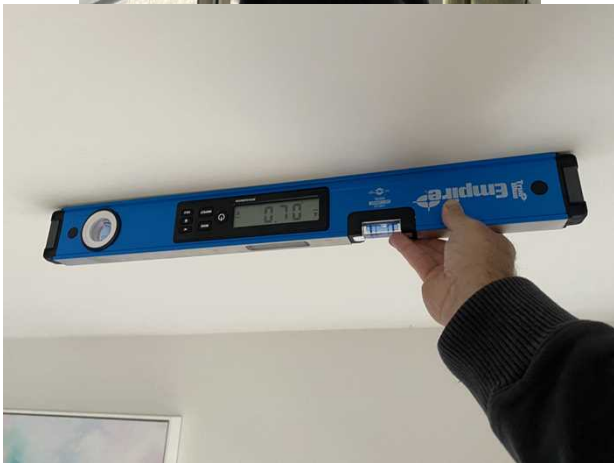
Plaster ceiling falling towards the kitchen/damaged area.
